# WOOD DESTROYING PESTS AND ORGANISMS INSPECTION REPORT

#: 20235388

| BUILDING NO.<br>18574 | STREET<br>TOMKI RD | CITY<br>REDWOOD VALLEY | ZIP<br>95470 | Date of Inspection<br>06/26/2026 | NUMBER OF PAGES<br>1 of 8 |

| GENERAL DESCRIPTION:<br>Single Family Residence and studio/workshop | Inspection Tag Posted:<br>Subarea. |

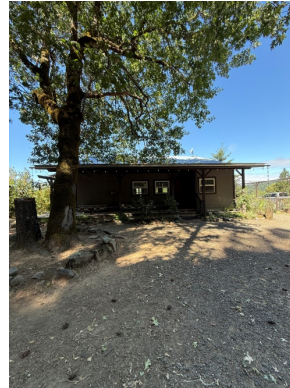
18574 Tomki Road

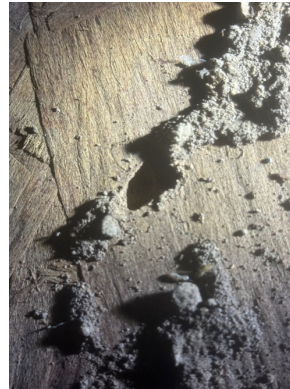
Evidence of Subterranean termites as indicated by 1A on the diagram. Evidence noted in cellulose debris in both structures.

1A- Live subterranean termites in the subareas

Due to the fact that there was evidence in several locations we recommend to complete a full treatment of both structures with Termidor SC and Premise 75 for control of Subterranean termites with a [5] year warranty. Owner is responsible for clearing personal belongings from subareas prior to treatment. Owner is also responsible for removing the (2) closest decking boards abutting the main structure at the north east side of the main structure to allow for trenching and treating the exterior of the foundation with Termidor. Owner is advised to install missing siding at the studio/workshop entry area to avoid disturbing soil after treatment, and for safety of pets. Price for treatment includes debris removal in both subareas.

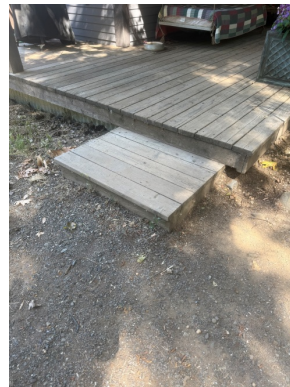
Earth to wood contact as indicated by 3A on the diagram. The contact was in the the handrail supports and steps at the wrap-around porch. Fungus damage was found to (1) handrail support at the north west side.

3A- Earth to wood contact at porch steps

Remove and replace support with earth to wood rated, pressure treated material, installing on concrete footing, lowering soil grade to break all earth to wood contact.

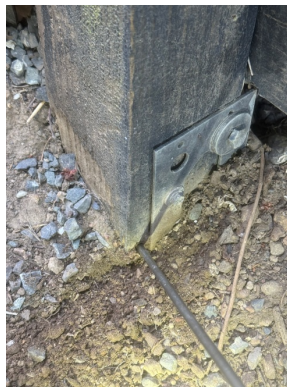
3A- Minor fungus damage to bottom of handrail support

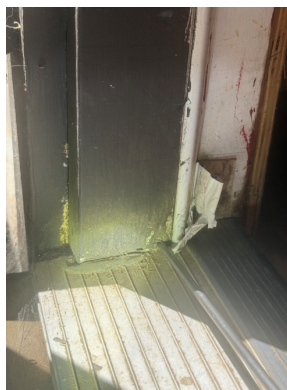
Fungus damage indicated by 3B on diagram. The fungus infection was noted in door jamb at the studio/workshop.

3B- Fungus damage to door jamb at the studio

Remove and replace all damaged material. If further conditions are found during repairs, issue supplemental report and price to complete. Paint new material to match and protect.

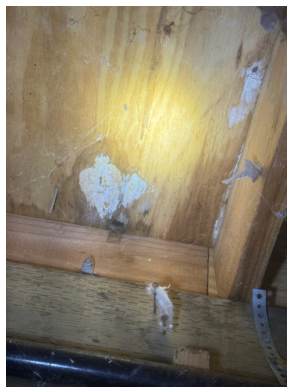
Fungus mycelium noted on subfloor at the south west side of the main structure as indicated by 3C on the diagram.

3C- Fungus mycellium growth noted on subfloor at the main structure

Wire brush and treat the fungus with timbor, an approved fungicide. Per state rules and regulations, a licensed applicator must be employed to apply fungicides, and pesticides. Mendo Lake Termite is licensed to apply these products.

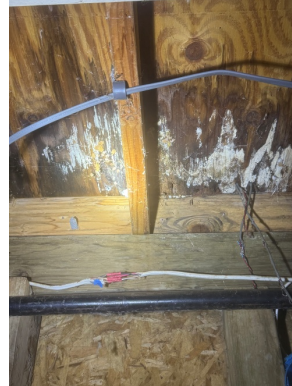
Fungus damage noted to subfloor at the south west side of the main structure at the door areas as indicated by 3D on the diagram.

3D- Fungus damage to subfloor at the main structure

Remove flooring, remove and replace the damaged subfloor, owner to employ flooring firm to install new floor covering as desired after repairs completed. Seal door, jamb, and install proper thresholds, properly flashing area as needed for moisture protection.

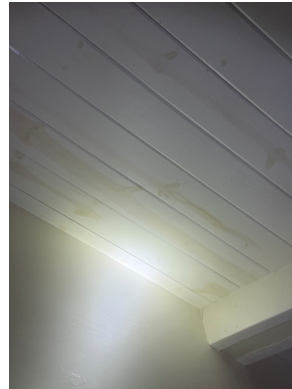
Water stains noted in ceiling area at the main house as indicated by 4A on the diagram. Inspection was made during dry weather and determination of present leaks could not be made at this time.

4A- Water stains noted in ceiling area of the main structure

We recommend to employ a licensed roofer for current roofing condition.

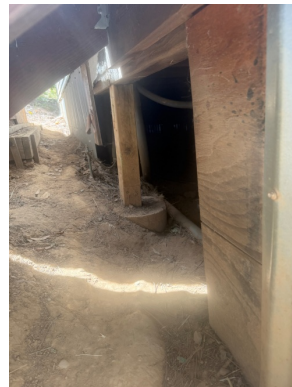
Siding was found missing at the front entry of the studio/workshop areas as indicated by 4D on the diagram. This could potentially allow a vermin or excessive moisture condition to occur.

4D- Siding missing at the studio entry area

Owner or contractor should be employed to correct and repair as needed for proper vermin and moisture protection.

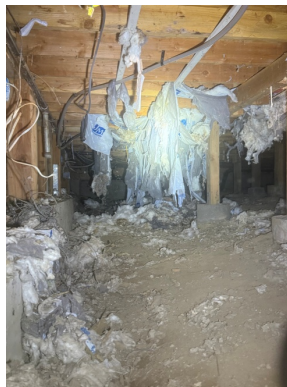
Insulation in the main structure subarea as indicated by 4F on the diagram was found to be falling down which blocks portion of the air flow vital for proper cross ventilation. Insulation has been pulled down by past vermin in the subarea.

4F- Insulation found falling down in the main structure subarea

Employ proper firm to repair/replace or remove insulation as needed to allow for proper air movement.

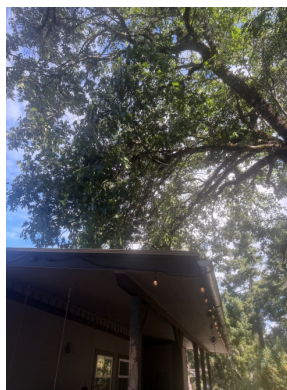
Tree overhangs the main structure's roof area at the north east as indicated on the diagram by 4H.

4H- Tree overhangs structure

Employ tree service or handy man to trim back the branches away from the structure and owner is to maintain.

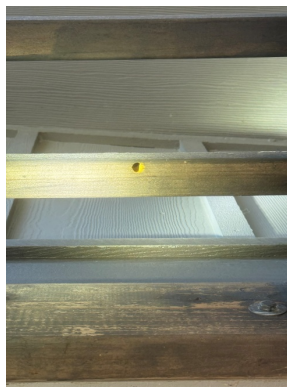
Indications of carpenter bee activity at the main structure noted as indicated by 4I on the diagram. No live infestation found at the time of this inspection.

4I- Carpenter bee activity at the porch area

If live infestation is found at a later date, owner should employ mendo lake termite to treat for control of Carpenter bees.

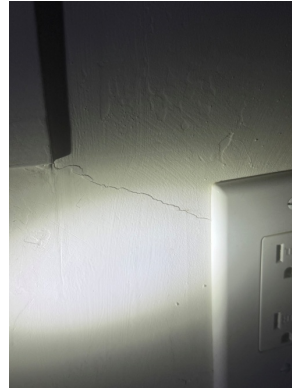
Cracked sheetrock as noted by 4J on the diagram. The crack was noted in wall area at the main house kitchen. This is normally as a result of settling.

4J- Cracked sheetrock at the kitchen area

Employ contractor to repair or for further information.

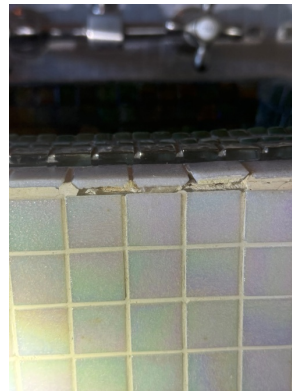
Grout is slightly deteriorated as indicated by 4K on the diagram. This is considered a condition conducive to fungus infection. The grout was deteriorated at the upstairs bathroom sink area of the main structure.

4K- Grout slightly poor at hall bathroom sink

Remove old grout and replace with new as needed.

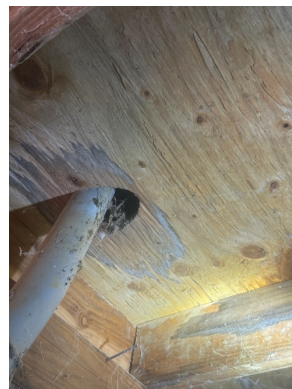
Water stains noted as 4M on the diagram. No moisture was noted. The stains were in subfloor due to past leakage at studio sink area. No present leakage noted.

4M- Water stains in subfloor at the studio

Owner to maintain plumbing and keep floors sealed.

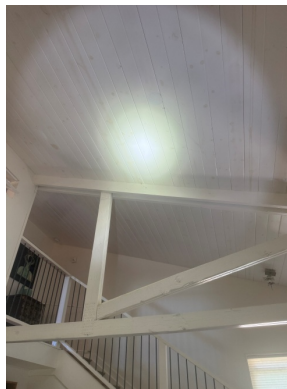
Attic at the main structure was inaccessible due to enclosed ceiling as indicated by 5B on the diagram. This is normal type construction with mobile homes.

5B- Enclosed ceiling at the main structure

If further information is desired we recommend further inspection after inspection holes installed in ceiling. Employ roofer for other information regarding roofing or construction.

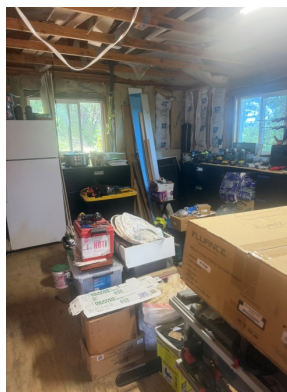
The studio, as indicated by 5C on the diagram, was found to be full of stored materials at time of inspection thus making portion of lower wall framing inaccessible for visual inspection at this time. No indications of adverse conditions in the areas above the storage.

5C- Stored materials in the studio

For further information we recommend reinspect this area after all stored materials have been removed from the garage.
