SYFERT INSPECTIONS LLC.

## INTERNACHI RESIDENTIAL

18574 Tomki Rd  
Redwood Valley, CA 95470

06/26/2026

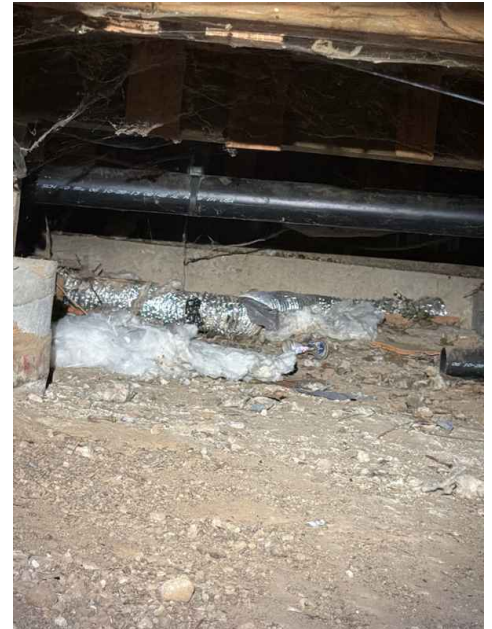
**DRYER DUCTING DAMAGED**

Dryer exhaust ducting is damaged and appears to be venting into the crawlspace rather than to the exterior. This can introduce excessive moisture and lint into the crawlspace, increasing the risk of mold growth, wood deterioration, and creating a potential fire hazard. Recommend having the dryer exhaust duct repaired or replaced as needed and properly terminated to the exterior

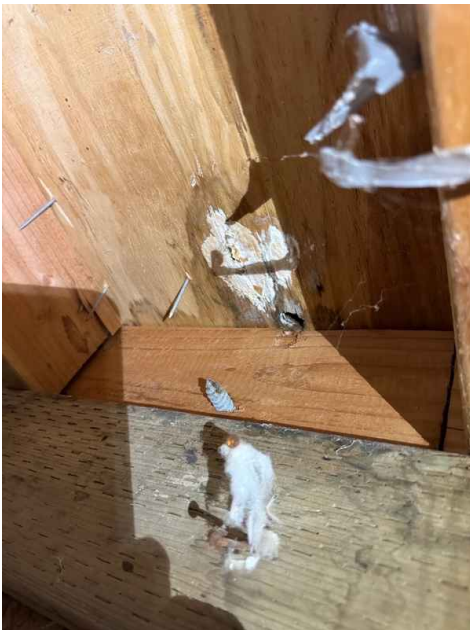
**EVIDENCE OF MOISTURE DAMAGE**

Sections of the subfloor exhibit moisture-related damage and deterioration. The source of the moisture could not be determined at the time of the inspection, and the full extent of the damage was not visible. Recommend identifying and correcting the source of moisture, followed by evaluation and repair or replacement of the affected subfloor by a qualified contractor as needed.

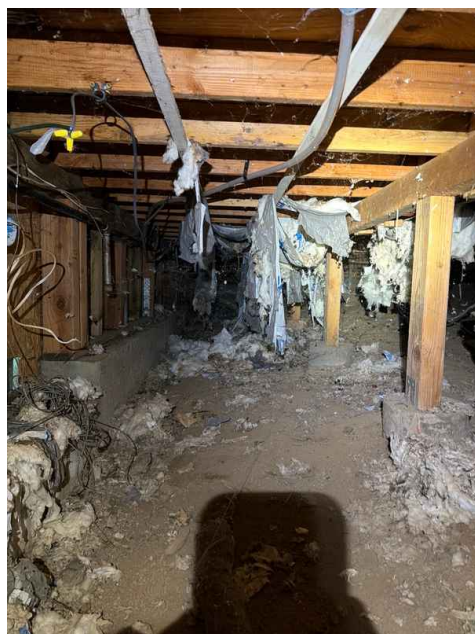
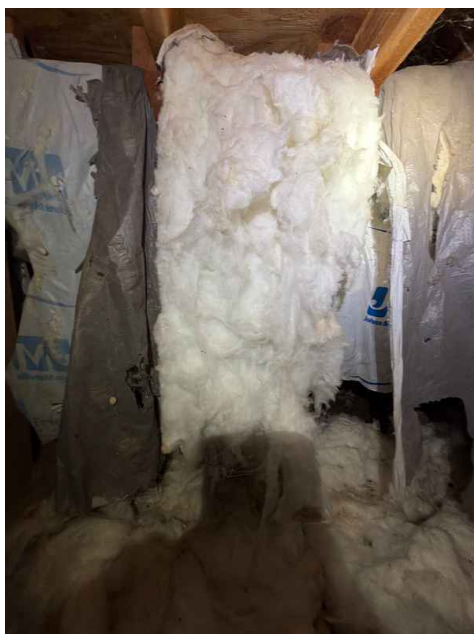
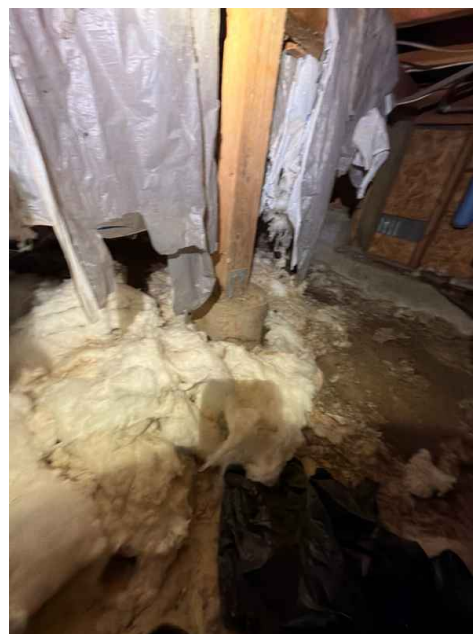
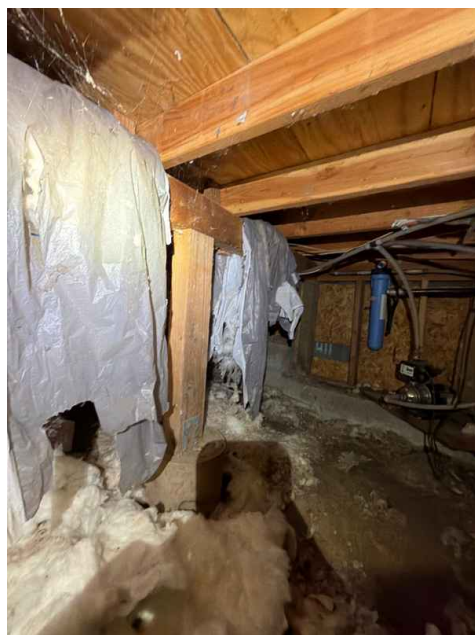
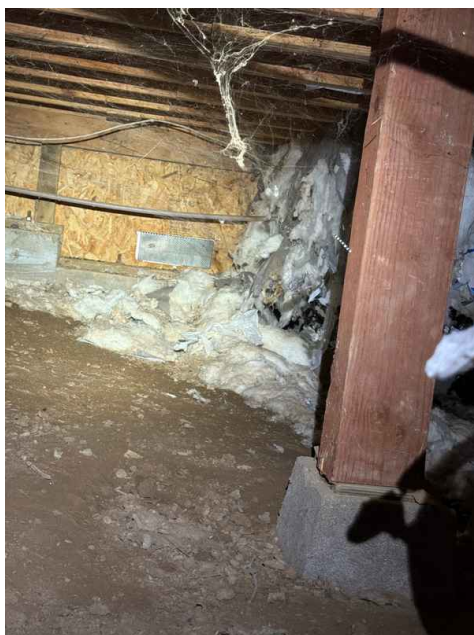
#### **DAMAGED INSULATION**

Damaged or hanging insulation found in the crawlspace area is recommended to be removed as the debris can attract pests and cause moisture issues.

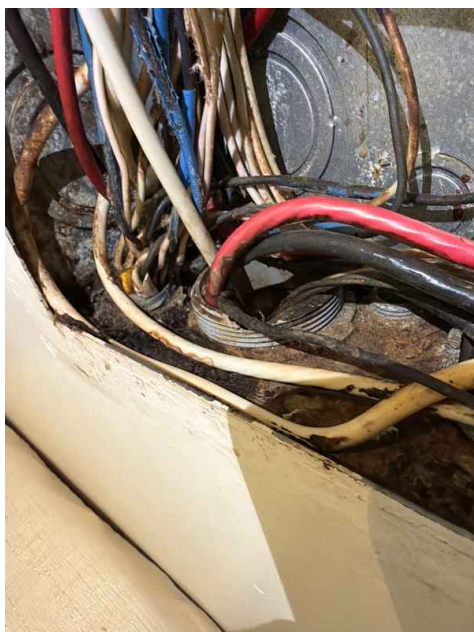
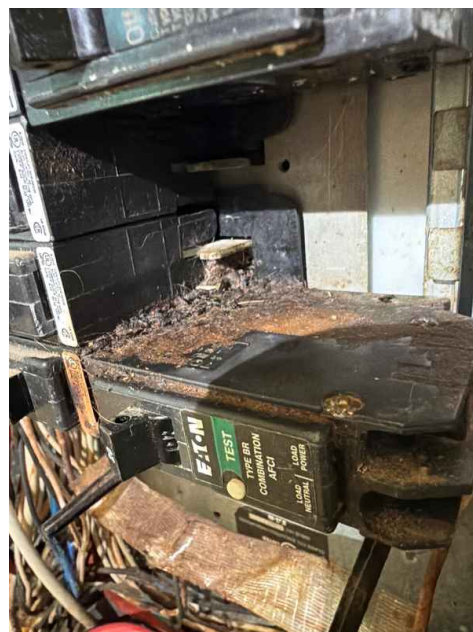
#### **DISCOLORATION/SUBSTANCE IN PANEL**

Discoloration and an unidentified substance were observed inside the electrical subpanel. The cause and significance of this condition could not be determined during the inspection. Recommend evaluation by a qualified electrician to determine the source of the discoloration, verify the panel is functioning safely, and perform any necessary repairs or cleaning.

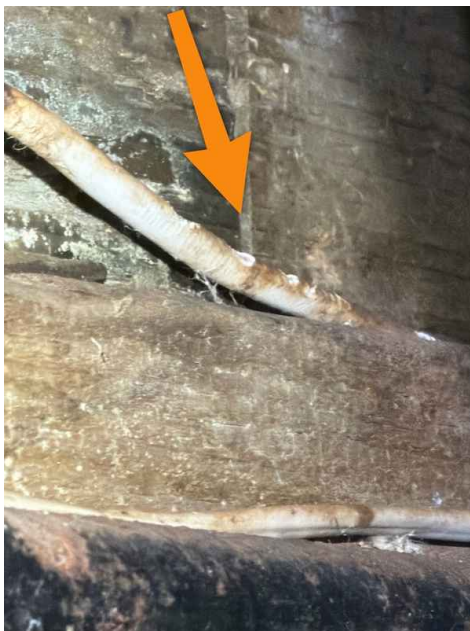
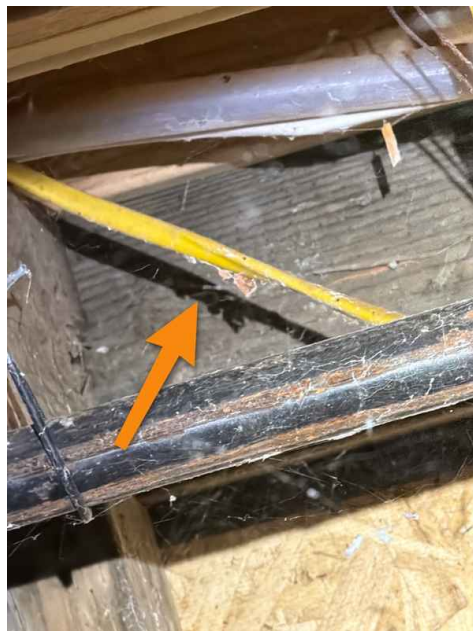
#### **DAMAGED WIRES**

Electrical wiring in the crawlspace was observed with apparent damage consistent with possible rodent activity. Damaged wiring can present a shock hazard and increase the risk of electrical malfunction. Recommend further evaluation by a qualified electrician and pest control professional to determine the extent of damage, address any active rodent activity, and repair or replace affected wiring as needed.

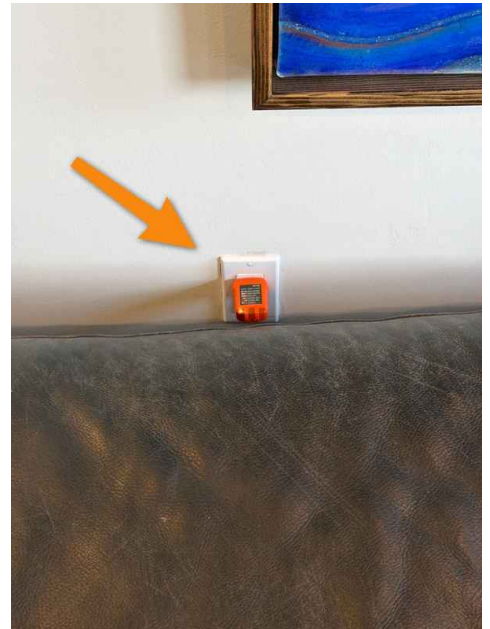
One or more electrical outlets were tested and did not have power. Cause for lack of power distribution cannot be determined and a qualified electrician should be contacted for a further evaluation

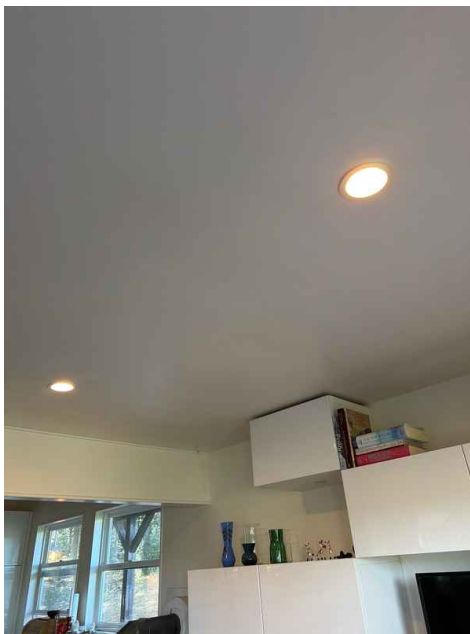
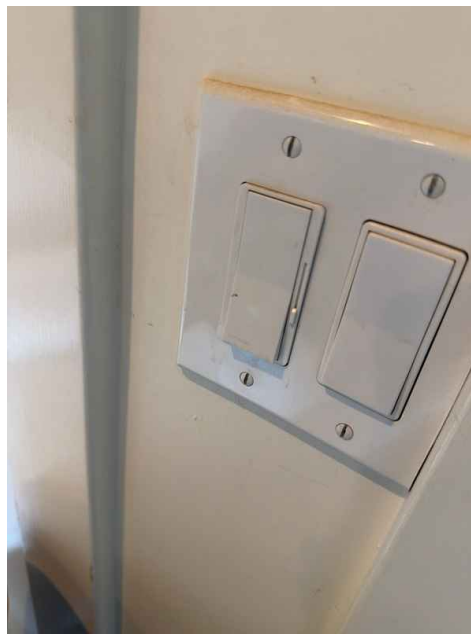
The dimmer switch for the two recessed light fixtures in the TV area do not adjust the brightness. This may indicate that the dimmer switch is not functional or the light fixtures are not dimmable

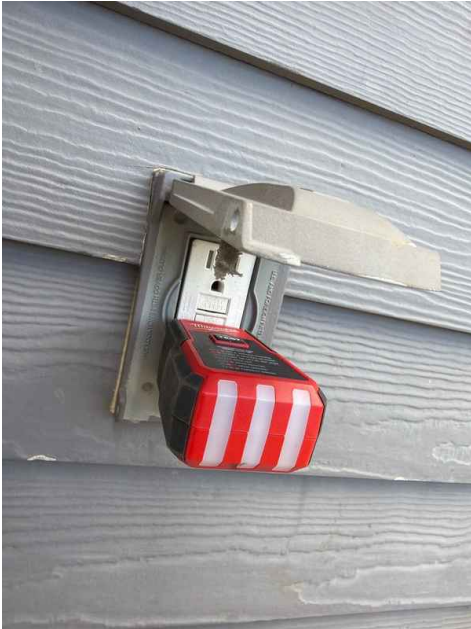
##### **FAULTY GFI**

One or more GFI outlets were not properly tripping or resetting which may indicate either a faulty outlet or improperly wired outlet should be corrected as needed by a qualified electrician.

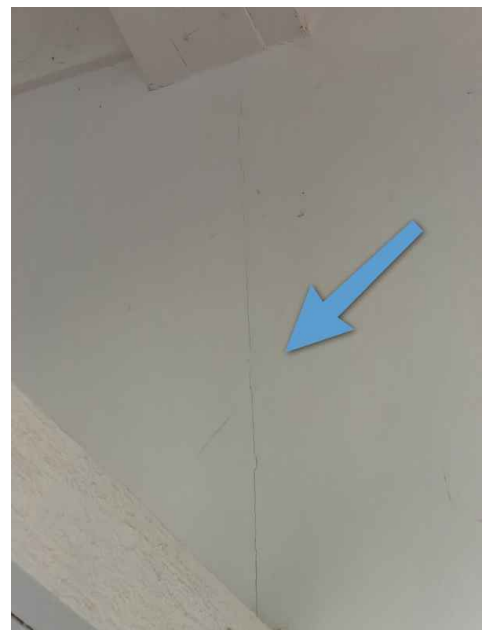
#### **LINEAR CRACKS**

Hairline cracks were observed on interior wall surfaces. These types of cracks are common in many homes and are typically related to normal settling or seasonal movement of materials. No signs of structural concern were observed at the time of inspection. Recommend monitoring the areas and repairing as needed for cosmetic purposes.

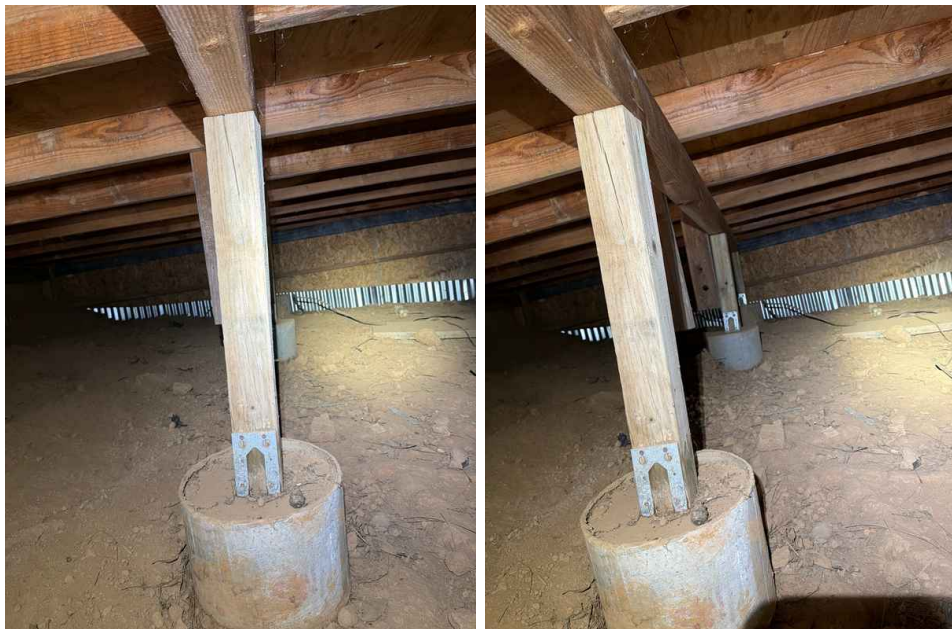
Some of the wood post-and-pier supports beneath the home were observed to be leaning downhill. The concrete footings did not appear to be displaced, and no visible structural distress attributable to this condition was observed at the time of the inspection. Because the cause and long-term significance cannot be determined during a visual inspection, recommend evaluation by a qualified contractor and correction as needed to ensure the supports provide proper long-term stability.

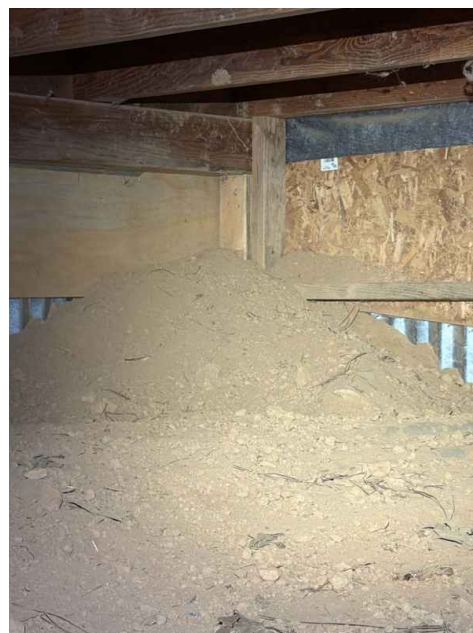
#### **SOIL IN CONTACT WITH WOOD**

Soil in direct contact with wood materials creates conditions for wood rot, decay, and pest infestation. This should be corrected to prevent structural deterioration.

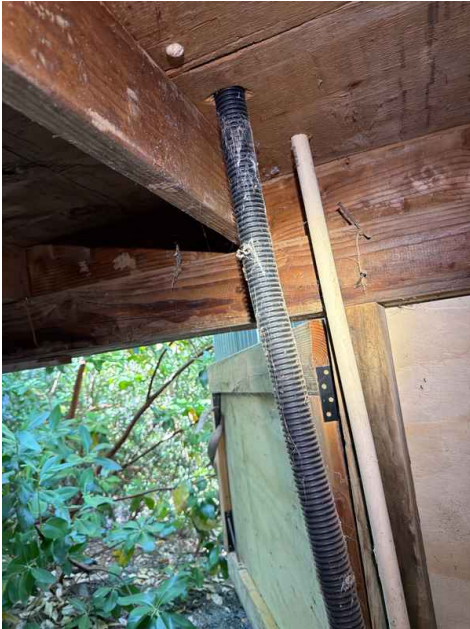
The art studio sink does not appear to be connected to the main septic system and instead drains toward the hillside. This is not a typical or approved drainage method and may lead to drainage issues or erosion concerns. Recommend having the system evaluated by a qualified plumbing contractor and redirected to an approved waste system as needed.

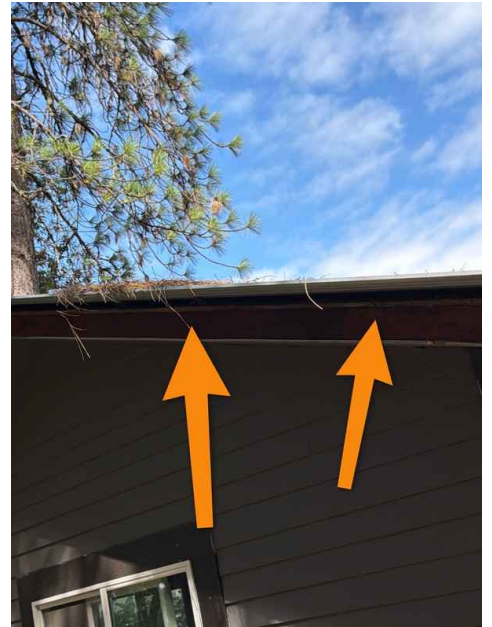
##### **OPENINGS ABOVE FASCIA**

Openings were observed above the fascia at each gable end, between the metal roof edge and the top of the fascia board. These gaps may allow moisture, wind-driven rain, pests, and debris to enter the roof assembly. Recommend further evaluation and repair by a qualified roofing contractor to properly seal and protect these areas as needed.
