# WOOD DESTROYING PESTS AND ORGANISMS INSPECTION REPORT

#: 20235388

| BUILDING NO.<br>18574 | STREET<br>TOMKI RD | CITY<br>REDWOOD VALLEY | ZIP<br>95470 | Date of Inspection<br>06/26/2026 | NUMBER OF PAGES<br>1 of 8 |

| GENERAL DESCRIPTION:<br>Single Family Residence and studio/workshop | Inspection Tag Posted:<br>Subarea. |

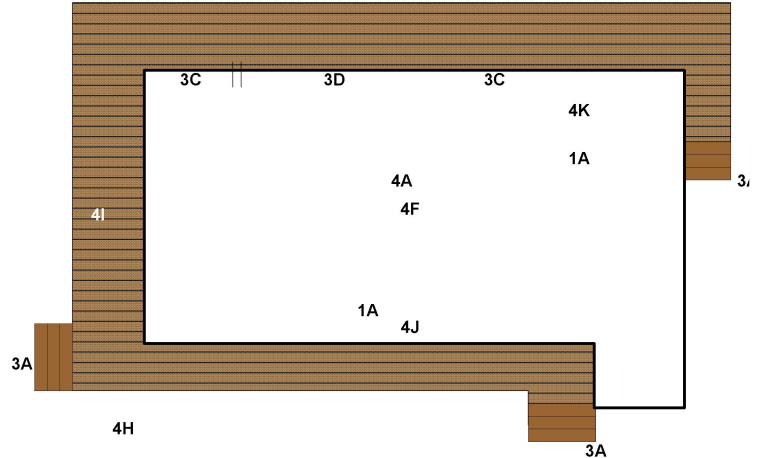
## Front of Structure

Evidence of Subterranean termites as indicated by 1A on the diagram. Evidence noted in cellulose debris in both structures.
